ICE Flow Corrosion Risk Management: Gold mine

System wide corrosion in gold mine: This site experienced many corrosion challenges due to the climate, acidic ore, low water quality and a lack of corrosion consideration in design. ICE deployed corrosion risk management program as well as reducing risk through corrosion engineering design.

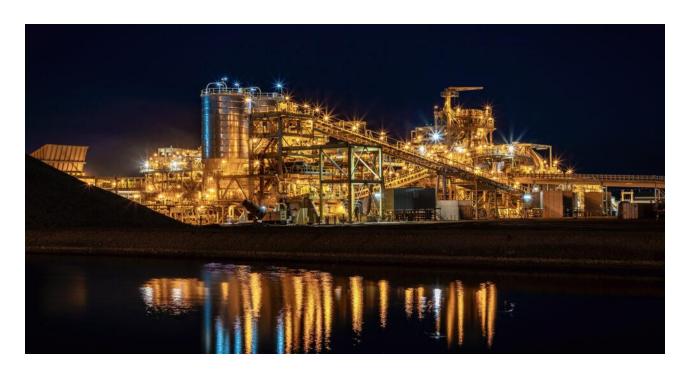
- Systemic and highly aggressive corrosion
- Hidden asset risks
- Unknown maintenance cost / production losses
- Reactive response / minimal skill set

- Technical solutions (riskbased prioritization)
- ICE Flow corrosion risk management
- Risk measured and quantified
- Risk-based work prioritization
- Accurate budgets and scheduling
- Financial impact understood
- No catastrophic failures

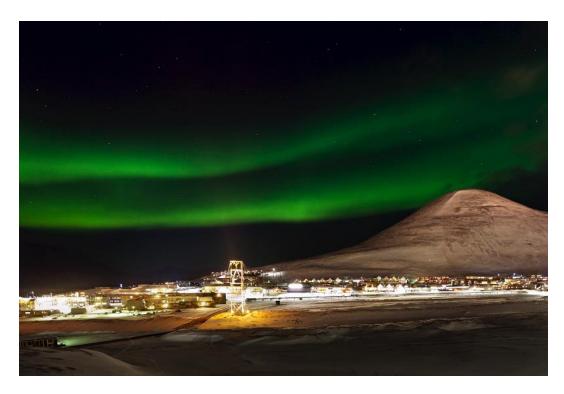
Gold mine using recycled process water: To reduce water use footprint in this remote, sensitive location, this mine recycles water. This results in high salinity in the process and washdown water leading to corrosion challenges. ICE deployed corrosion risk management program (with full site presence) as well as reducing risk through corrosion engineering design.

- Saline process water = rapid onset of corrosion
- High corrosion rates on structures, tank externals, piping, cladding, ducts, handrails etc
- Remote location (difficult access to resources)

- Proactive corrosion control input at design stage
- Development and implementation of a corrosion risk management plan (ICE Flow) to stay on top of the risk over the life of the mine (35yrs)

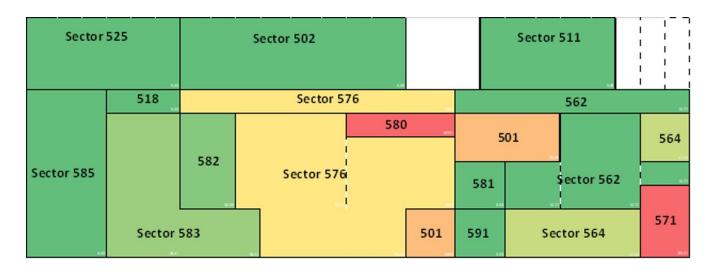
This site had high levels of salinity in the washdown water which reduced the longevity of structural steel and coatings. Risk was understood through quantitative data collection to allow prioritization of maintenance work.

High salinity washdown water = corrosion of structural steel

- Created a standard visual inspection proforma for steel in the process plant
- Collected quantitative corrosion data (coupons, UT measurements, exposure data)
- Created a corrosion risk map for tracking and predicting risk
- Updated the coating specification to match the risk type
- Carried out annual audit inspections to track risk and optimize repair

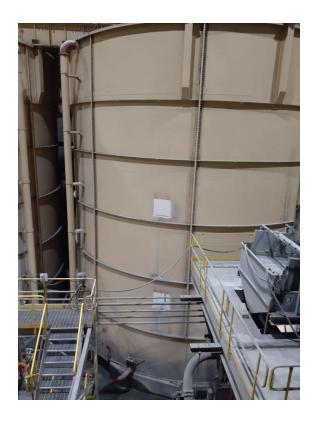
After 1 year of operation, CIL process tank inspections revealed higher than expected wear and pitting corrosion. ICE specified liners and oversaw the project to line the tanks and increase service life.

- Entrained solids plus chlorides
- Unlined CS process tank x 6
- 1 year in operation
- Pinhole leaks from erosion-corrosion
- Pitting up to 1 mm depth

- Analysis of risk vs. operation
- Specification of internal liner system
- QA/QC design and oversight
- Working well after 1 year in service

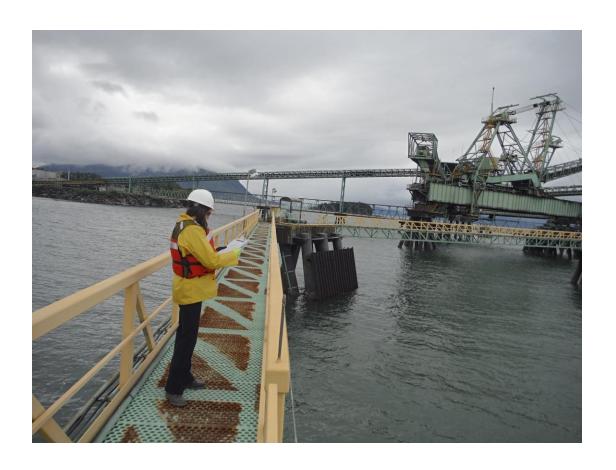
Coal terminal structures required an upgrade to their CP systems to ensure continuing longevity for their extended service life.

Marine exposure of port structure / CP system not functioning well

- Inspection / review of existing CP system and condition of submerged piling of port
- Re-design of new galvanic anode CP system
- Construction support
- Commissioning of CP system
- Training of client team to carry out annual inspection

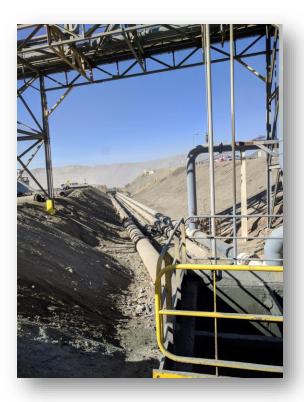
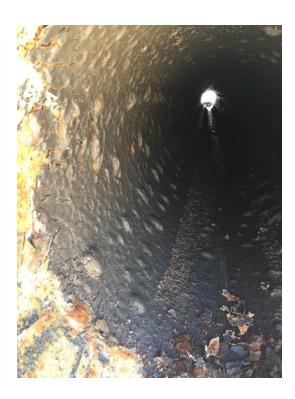
Section of long water conveyance pipeline had not been lined in construction. Pinhole leaks occurred. Incumbent water treatment was ineffective and giving client false sense of security.

- The conveyance line was exposed to mixed waste/stormwater/desal water.
- Failures occurred due to MIC (Bacterial attack) – this risk was not accounted for in design or corrosion protection strategy.
- The water treatment program in place was not able to effectively identify, control and monitor corrosion risks.

- ICE team identified the corrosion risks through inspection and analysis of operational/maintenance data.
- A modified water treatment plan was developed with improved corrosion inspection and monitoring to prevent future failures.
- Client changed water treatment company.

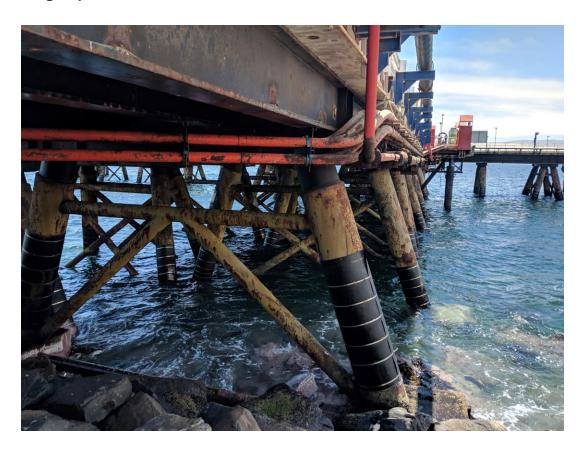
Cathodic protection system had been installed on the port structures during construction but had not been regularly maintained or monitored, resulting in an integrity risk to UW structures.

- Site inspections revealed that the marine structures were under-protected due to failed cathodic protection system and severe coating damage.
- System failure was not detected due to lack of inspection and monitoring leading to structural damage.

- System modifications were developed to achieve required protection.
- On-site training for inspections and a monitoring plan was put in place for future maintenance and to prevent future failures.

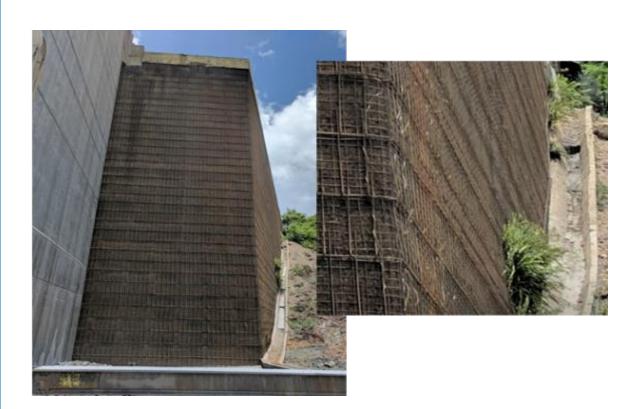
Mechanically stabilized earth wall had not considered the impact of acidic ore corrosion on the galvanized structural rebar. Several sections of rebar corroded through. Considered a critical asset in the crushing circuit.

- Mechanically Stabilized Earth wall was showing damage from corrosion of galvanized steel bars and meshes from acidic ore leaching into the ground.
- This wall supports the loading platform for the initial ore crusher. Loss of structural integrity would cause production to stop.

- Performed lab testing to estimate remaining life of the galvanized steel structures.
- The worst areas were encapsulated with concrete and galvanic anodes were installed. A corrosion monitoring systems to track corrosion activity was installed on the repaired (high risk) areas.

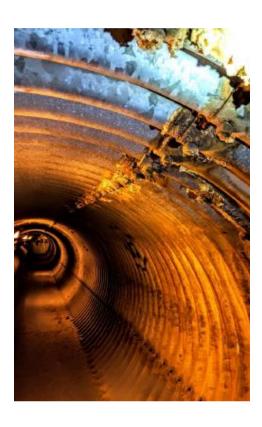
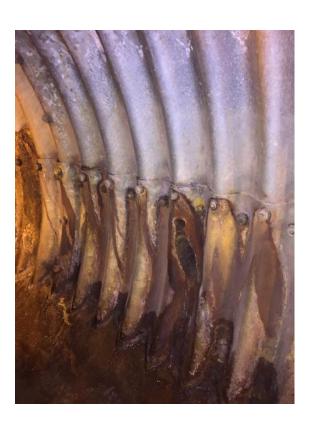
Lack of corrosion consideration in design meant that material selection for the stockpile conveyor tunnel was inappropriate for the conditions.

- Corrosion of corrugated steel tunnel liner from acidic soil and stockpile runoff (pH1-2).
- Through-wall corrosion in 6 years.
- Loss of structural integrity would cause safety concerns, production stoppage, and costly unscheduled repair.

- Recommended a repair plan which prevented a costly failure.
- Specified excavation, concrete encapsulation of the whole structure and local repair of the steel.
- Have since included the tunnel and conveyor into inspection and maintenance planning

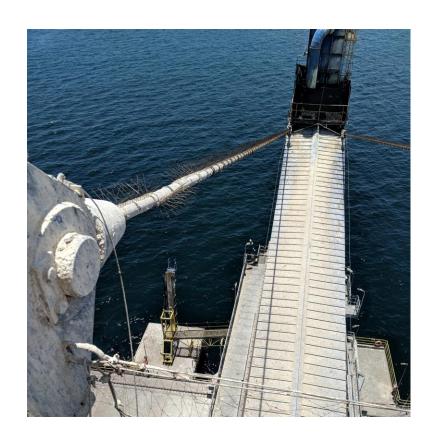
Catastrophic and fatal failure of a ship loader at a nearby port created urgency for client to carry out an inspection of their ship loader. Visual inspection considered insufficient to make a decision on condition.

- Coastal / marine exposure of ship loader structure / cables – unknown corrosion damage
- Bird 'activity' obscured visual inspection
- Needed quantitative data to determine remaining service life.

- Site inspection of ship loader
- Specification for cable crawler NDT inspection to determine corrosion thickness loss
- Data analysis and planning for client for cable replacement – allowed budgets and planned replacement (not reactive)

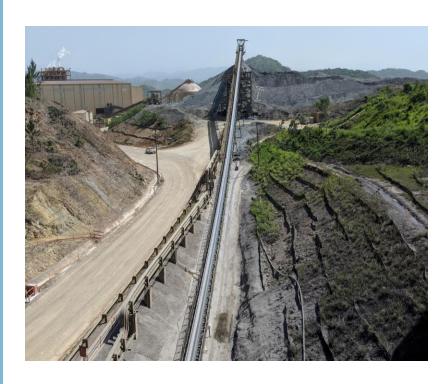
Conveyor (crusher to stockpile) in warm, humid climate, and acidic ore dust was corroding faster than expected. Risk was particularly high under deposited material on the structure at the top and around columns. Considered a critical asset.

- Coatings selected in design were insufficient for exposure
- Conveyor structure rapid corrosion / difficult to inspect and recoat

- Created an inspection and maintenance decision protocol
- Updated coating specifications
- Trialed a 'lime wash' approach to reduce acidity on structures

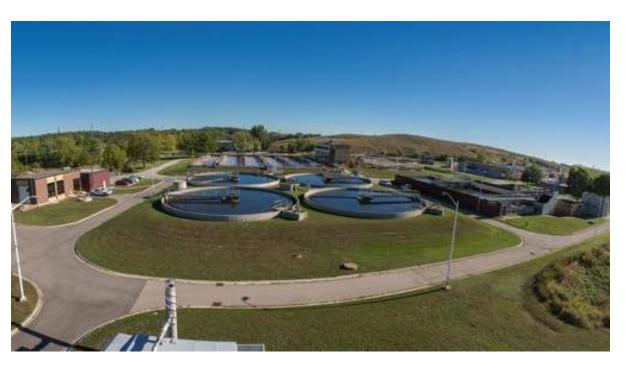
Wastewater treatment facility required a structured approach to dealing with aesthetic surface corrosion on a plant open to the public.

Lack of alignment in management expectations on coating upkeep versus the perspective of technical risk from maintenance team.

- A solution which integrated the operations and management teams on the maintenance strategy
 - **Management**: policy document, define KPIs and targets, communication plan, risk prioritization, etc.
 - coating specification update, repair strategy, inspection protocol improvement, risk ranking scheme, etc.

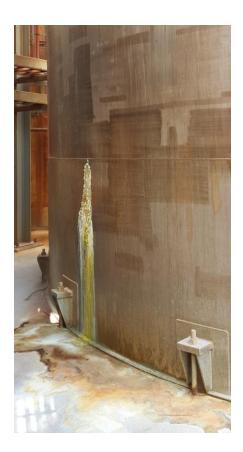
Stainless steel (316) process tank had pinhole leaks after ~1 year in service. Cause and extent of damage were unknown.

Cost \$250k/day to have it offline with possibility of structural collapse.

- Failure analysis revealed MIC attack of welds water quality / lack of control over internal conditions during commissioning.
- X-ray mapping to find extent of damage needing to be cut out and patched.
- Short-term repairs carried out and tank reentered service:
 - Prevented structural failure of tank
 - 'Limited' downtime costs to \$50M by accelerating the failure analysis and design of a solution

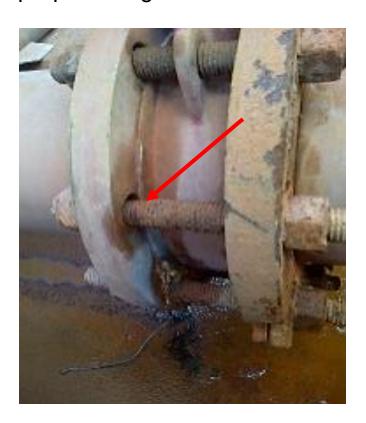
Electrical connection of dissimilar metals must be avoided in design AND construction (field changes). Here the galvanic corrosion of steel bolts was dealt with by operations by replacing like-with-like, perpetuating the issue.

- Carbon steel bolts vs. SS flange
- Significant loss of steel after 1 year
- Vibration / leaking / loss of containment from pipe

Flagged the issue and provided input into material selection for the bolts

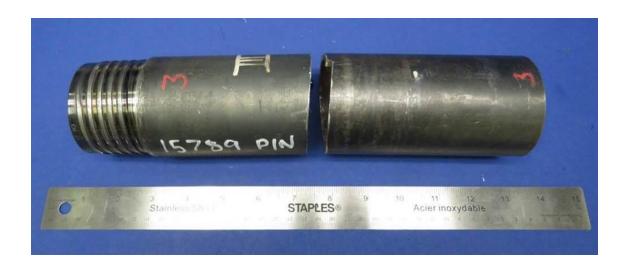
Intergranular stress corrosion cracking in high strength carbon steel exposed to aggressive soil / groundwater with high levels of chlorides.

- Failures within weeks due to brittle fracture.
- Static stress residual (from forming/welding) or applied
- Environment corrosive due to the presence of aggressive species, pH, temperature
- Material susceptible to corrosion in the environment in question

- Provided analysis of the cause of failure
- Recommended preventative actions
